**US Army Corps  
of Engineers**

USACERL Technical Report FE-95/04  
November 1994

# **Improving Central Heating Plant Performance at the Defense Construction Supply Center (DCSC)**

## **Advanced Operation and Maintenance Methods**

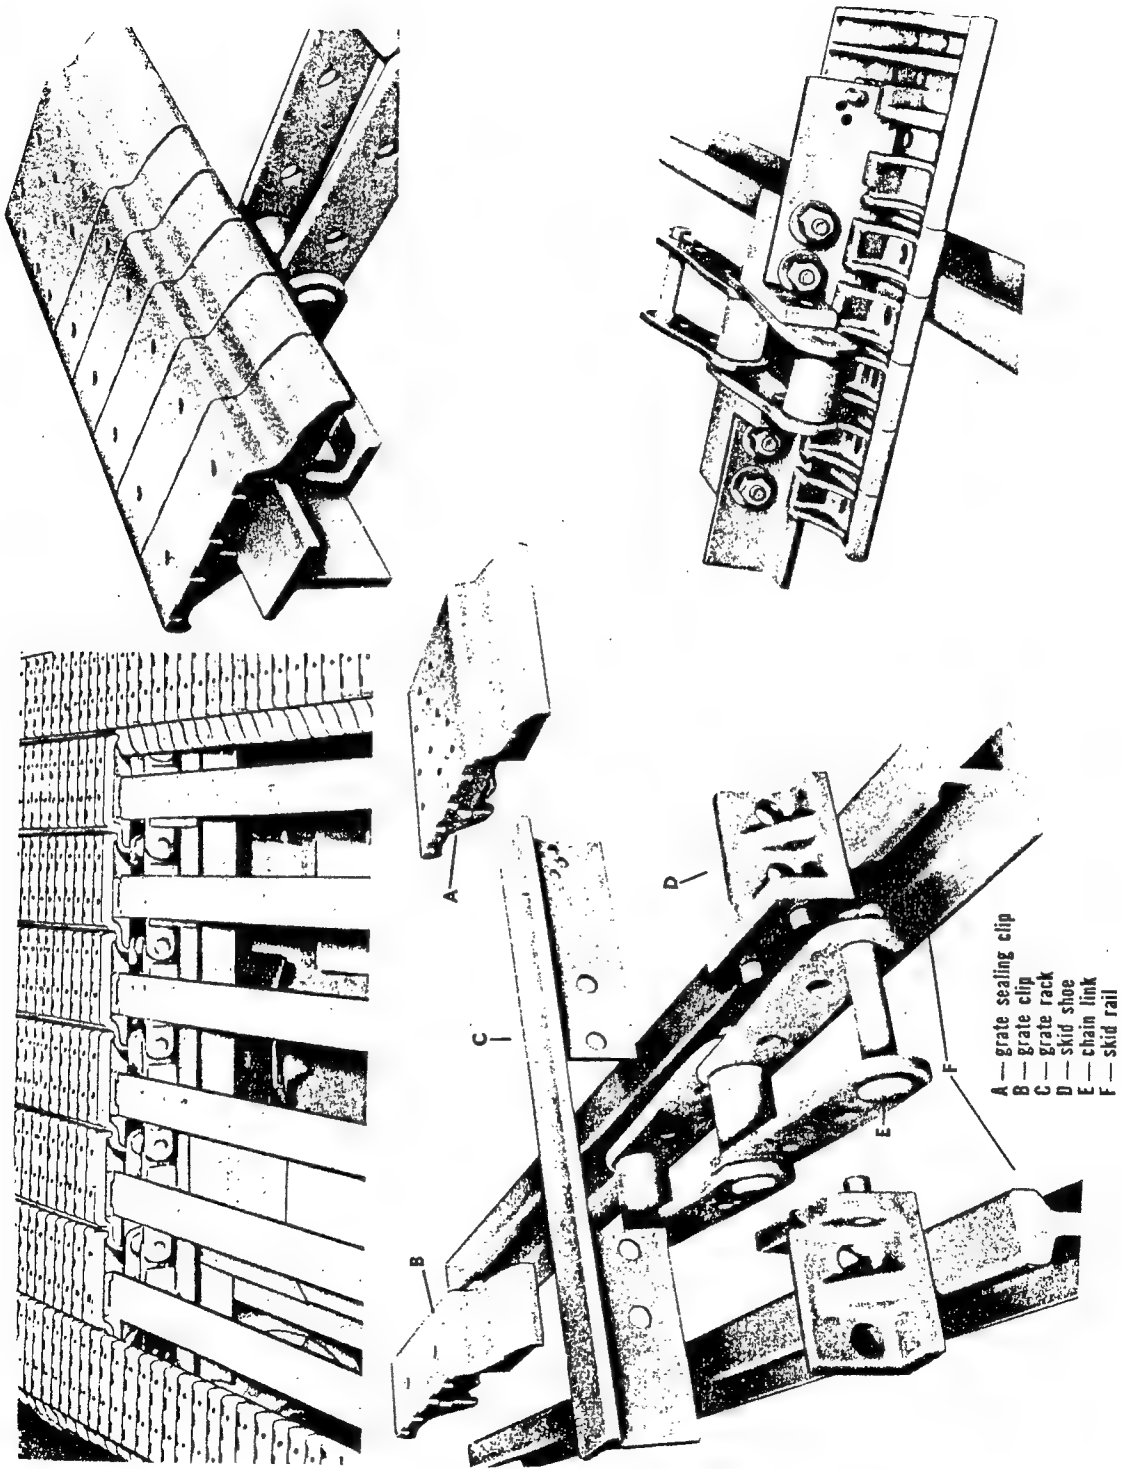
Figure 8. Grate surface.

**Grate.** Figures 11, 12, and 13 show important details for traveling grate operation. Of particular importance are: grate clips, air seals, and drive mechanism. The traveling grate on HTWG no. 2 was in excellent mechanical condition. The grate clips were sound and the skid shoes appeared almost new. The bearings on both the drive shaft and the idle shaft were in very good condition. The bearing inserts did not need replacement at that time. The shaft aligning collars on both shafts were secure and properly set for running clearance. The grate surface was square within the furnace.

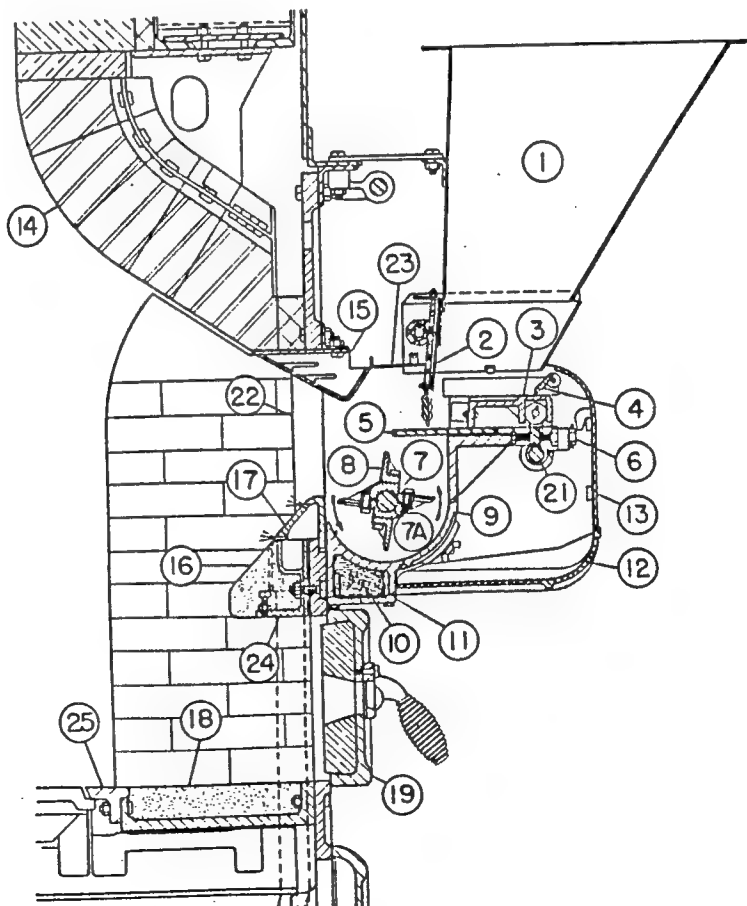
Figure 9. Coal feeder.

**Coal feeders.** All three HTWGs have Model B Riley Spreader Stoker feeders. A careful inspection of HTWG no. 2 and 3 feeders showed that they were in excellent mechanical condition. No replacement of parts was necessary. However, observation of the lateral coal distribution on units no. 1 and 3 indicated that modification of some of the distributor paddle angles was needed to improve lateral coal distribution over the grate area. Figure 10 shows the existing paddle angles followed by the suggested arrangement. The improvement in coal distribution over the grate area will permit complete combustion of the fuel with less excess air.

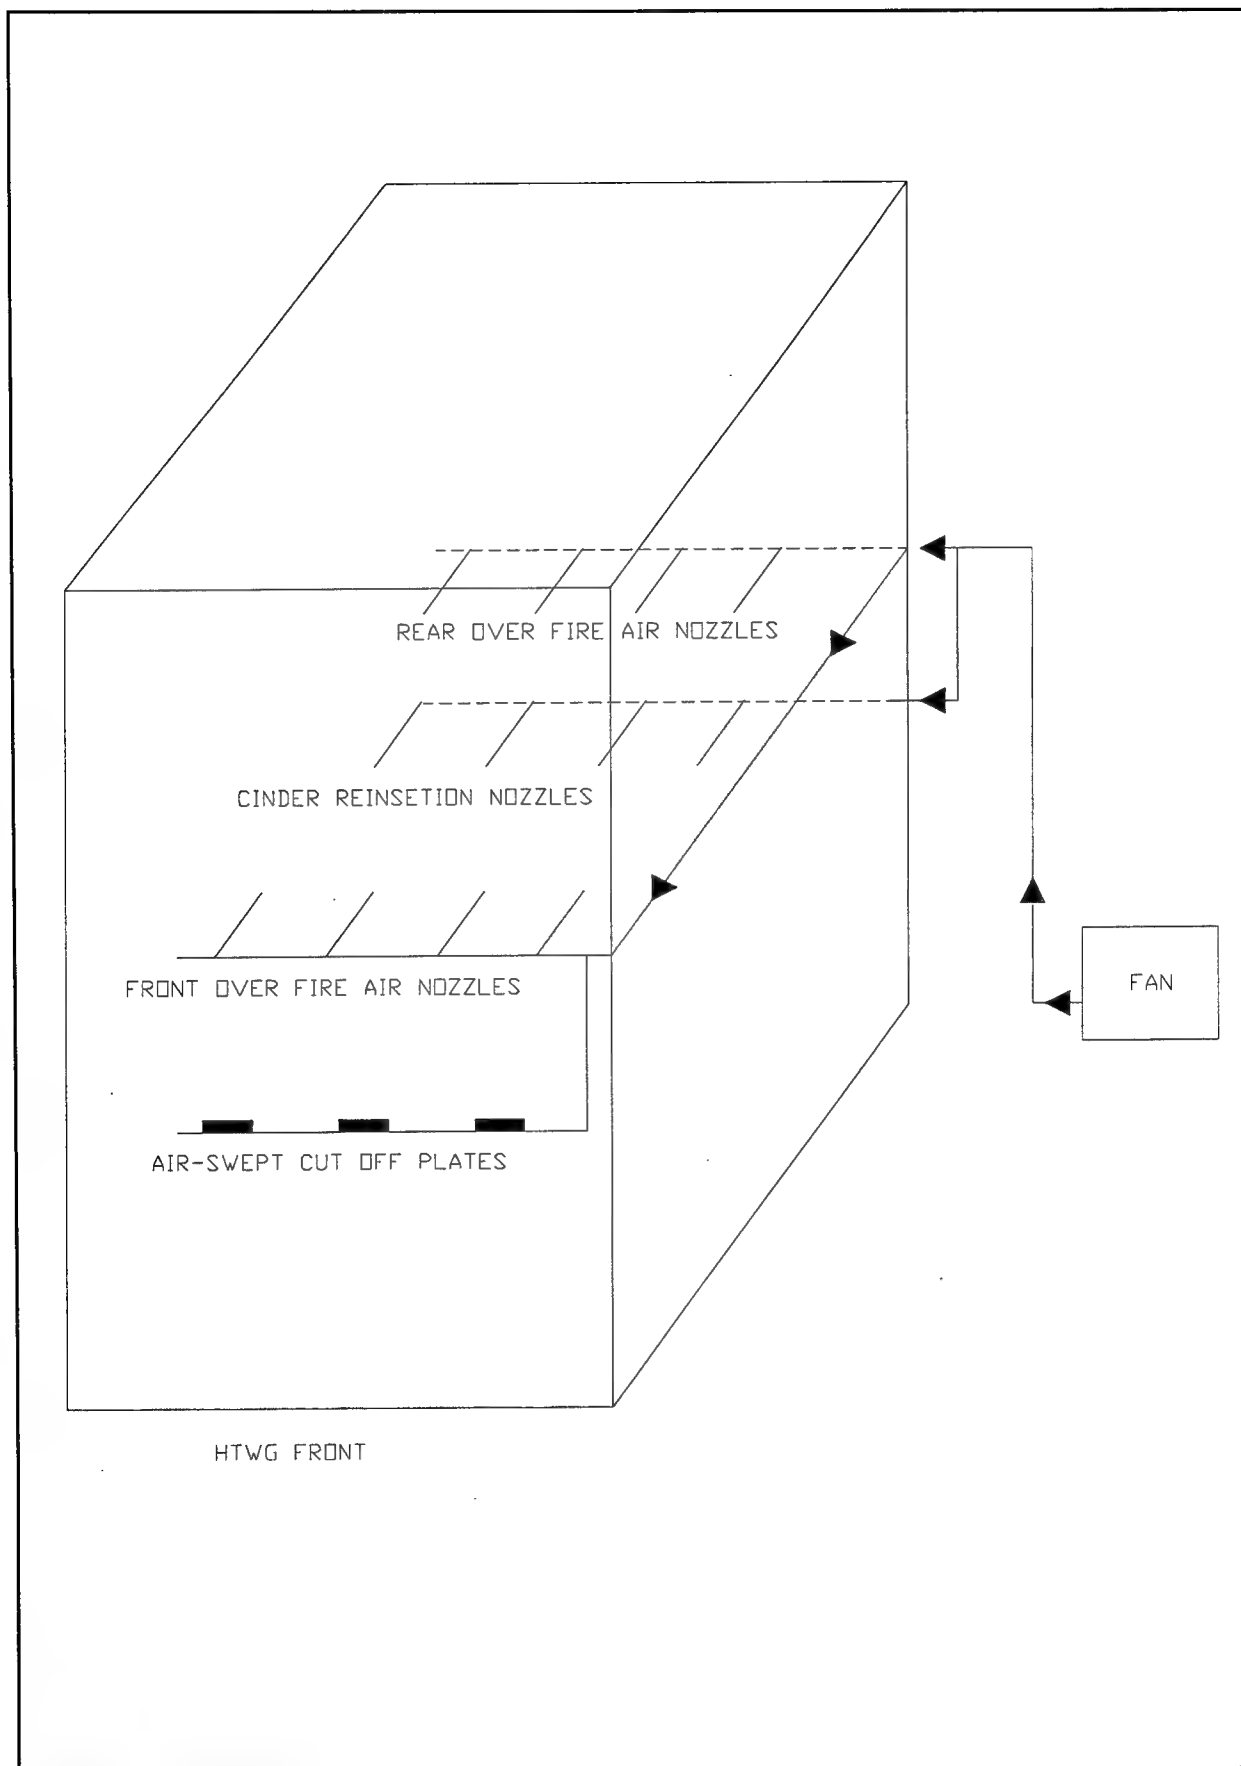
Figure 14. Overfire air system schematic.

The overfire air systems for all three units are identical. Figure 14 schematically represents the overfire air system. Each has a single fan that discharges into two headers. A front header serves the air-swept cut-off plates in each of the three feeders. A rear header serves both the one row of overfire air nozzles and the three cinder reinjection nozzles returning fly-ash from the HTWG last pass hopper to the furnace. The fan produces a maximum of 25 in. static pressure. For maximum effectiveness, the rear overfire air nozzles should have at least 25 in. of static pressure for this furnace design. The ash reinjection nozzles can use about 10 in. of static pressure. Since both are fed from the same header, either one or both, must be compromised. This system should be redesigned to take advantage of newer and more effective designs.

On HTWG no. 2, one of the overfire air lines passing through the hopper was defective. The 2-1/2 in. pipe was broken at a pipe flange and was separated by about 2 in. Because of this leak, about 50 percent of the air supplied by the fan was escaping into the last pass hopper.

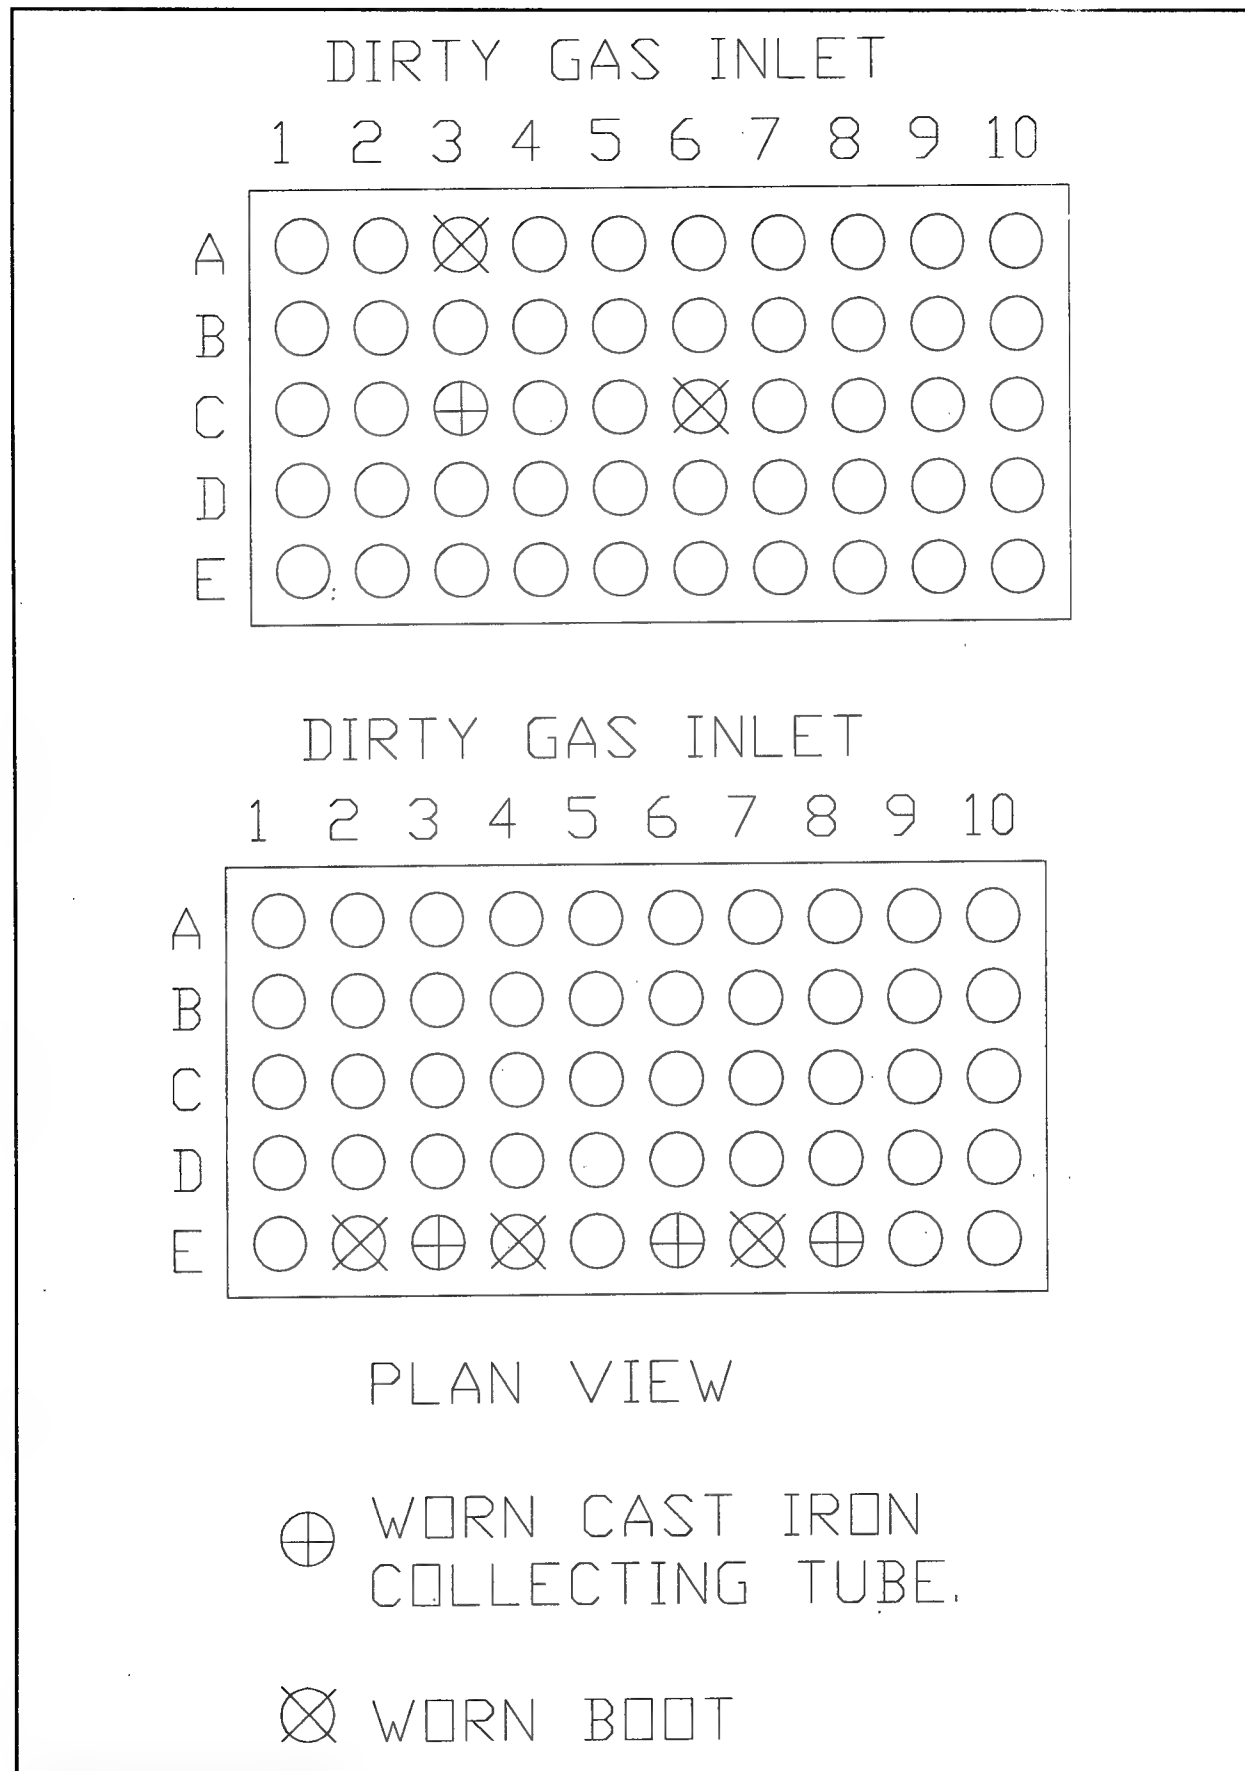
Figure 18. Mechanical collector inspection.

Each HTWG was equipped with a split mechanical dust collector. There were 25 multicyclones in each of the two sections. To maintain collector efficiency at light loads, there was a five-bladed damper ahead of one section of the collector. The damper was adjusted to maintain proper pressure drop across the collector. The dampers on each unit were frozen in the open position. (The heat of the flue gas had caused the grease in the damper bearings to carbonize.) Penetrating oil was injected into the bearings to free them. The damper shaft was also realigned. During preliminary testing, the pressure drop through the collector increased by about 1/2 in. of water or from 1 in. to 1-1/2 in. by closing this damper.

On both HTWG no. 2 and 3, the outer and inner tubes of the collector were in good condition. The turning vanes in both the outer tubes and inner tubes were in good condition. The collector on HTWG no. 2 had three cracked and dirty gas tubes and three worn discharge boots. The collector on HTWG no. 3 had one cracked and dirty gas tube and two loose discharge boots. Figure 18 shows the location of these defects. These relatively minor conditions can destroy the vertical vortex, essential to particle removal, and reduce collector efficiency.

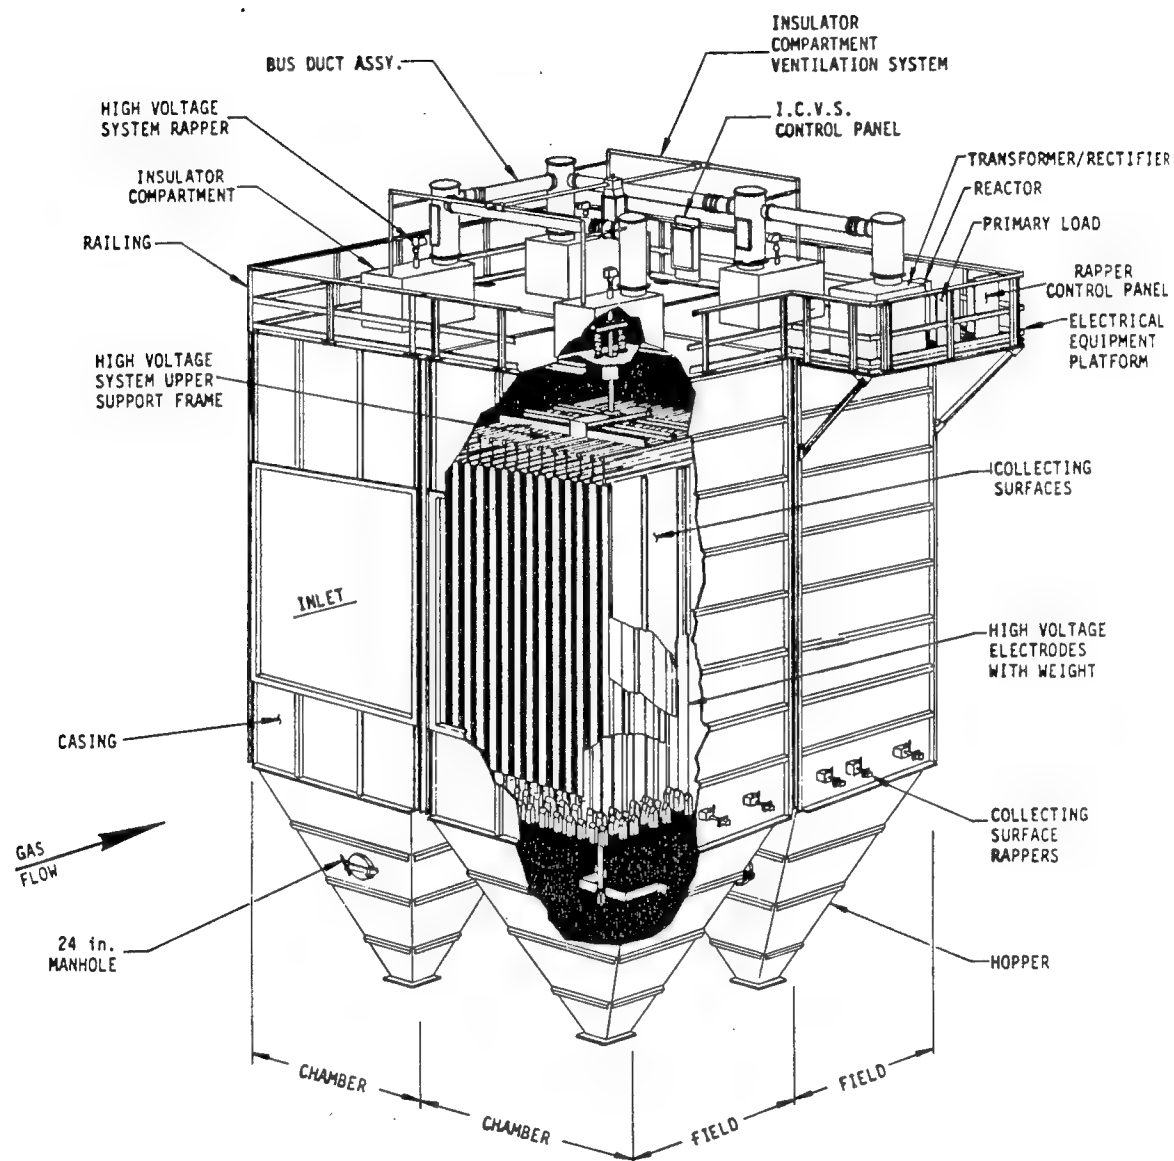
Figure 19. Electrostatic precipitator.

USAEHA personnel noted that the ESP had a number of warped collection plates and broken discharge electrodes. Conventional weighted wire ESPs typically have passage width tolerances of plus or minus 0.5 in. Warped plates can easily exceed these tolerances and cause increased sparking at the points of close collection plate/discharge electrode spacing, which results in substantially reduced secondary voltages in the field. This condition has a very adverse impact on the fly ash collection

efficiency. Broken discharge wires cause the same problem as they get bounced around by the flue gas flowing through the ESP.

The warped collection plates were most likely caused by high temperatures in the ESP resulting from hopper fires. Hopper fires occur when the ash has a high combustible content and there is significant air infiltration in the hopper area.

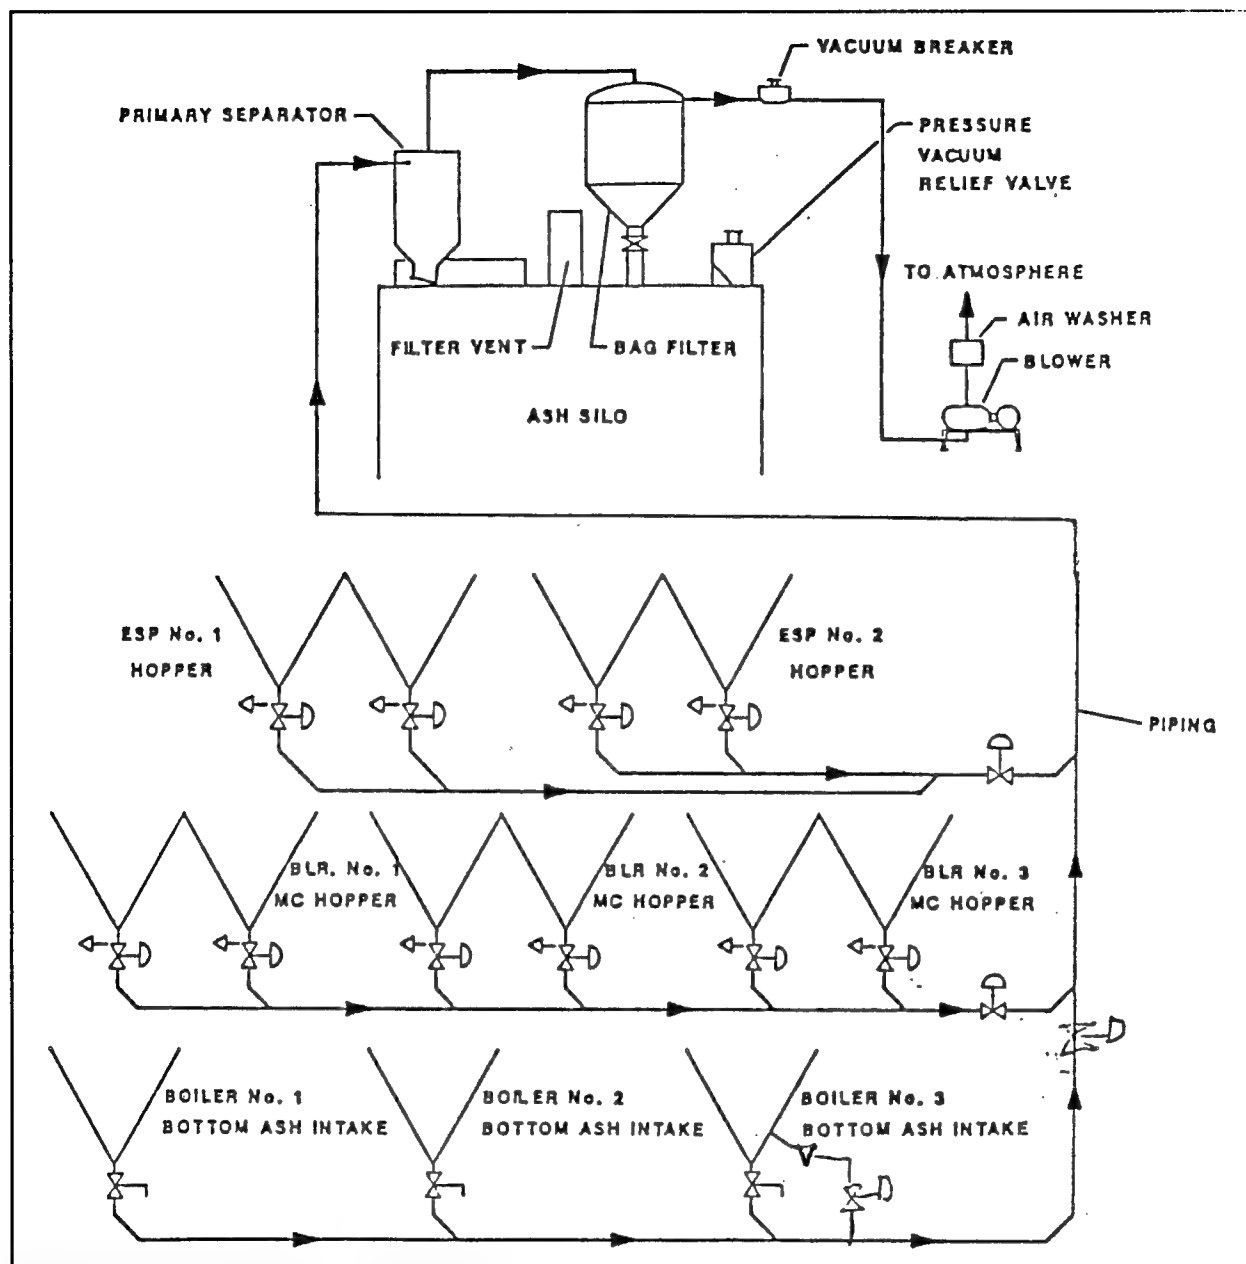
Figure 20. Pneumatic ash handling system.

Current operating procedure was to open the ash valve on the bottom of a mechanical collector or ESP and allow the ash handling system to be in normal operation. The vacuum is on the ash handling system for a short amount of time; i.e., 2 minutes, and then the vacuum is turned off the ash handling system by using a vacuum breaker for 1 minute to allow the accumulated ash in the primary separator to drop into the ash silo. When the vacuum was not on the system, it was not customary to close the ash valve on the bottom of the mechanical collector or ESP. Since the hoppers of the mechanical collectors and ESPs are under negative pressure, ambient room air would

flow in through the ash pipe and up through the valves into these negative pressure hoppers, carrying fly ash to the generator I.D. fan and contributing to erosion and air pollution at the ESP hoppers.

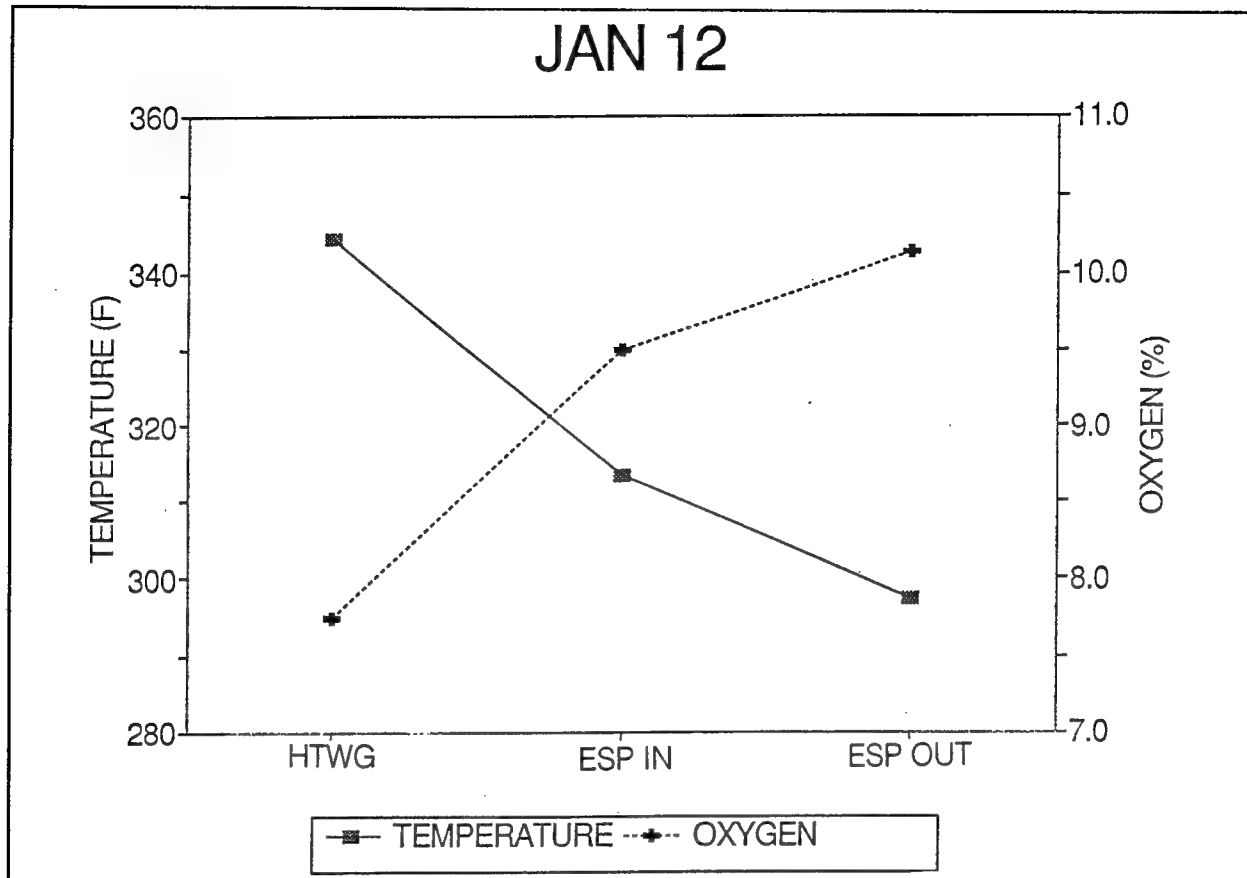
Figure 23. Pre-compliance test air infiltration.

Table 9 summarizes the combustion and air infiltration data from the test runs. The average plant output was about 72 MBtu/hr with a combustion efficiency of about 86 percent. Figure 23 shows the air infiltration through the ductwork and ESP. As expected, the temperature and oxygen in the flue gas are inversely proportional. The graph indicates a significant amount of infiltration between the HTWG and the ESP inlet caused by leaking bypass dampers and stack caps. However, the temperature is well above the 220 °F acid dewpoint required. Again, it should be noted that the temperature must be 300 °F or higher to ensure temperature above 220 °F at the outside walls of the ESP.

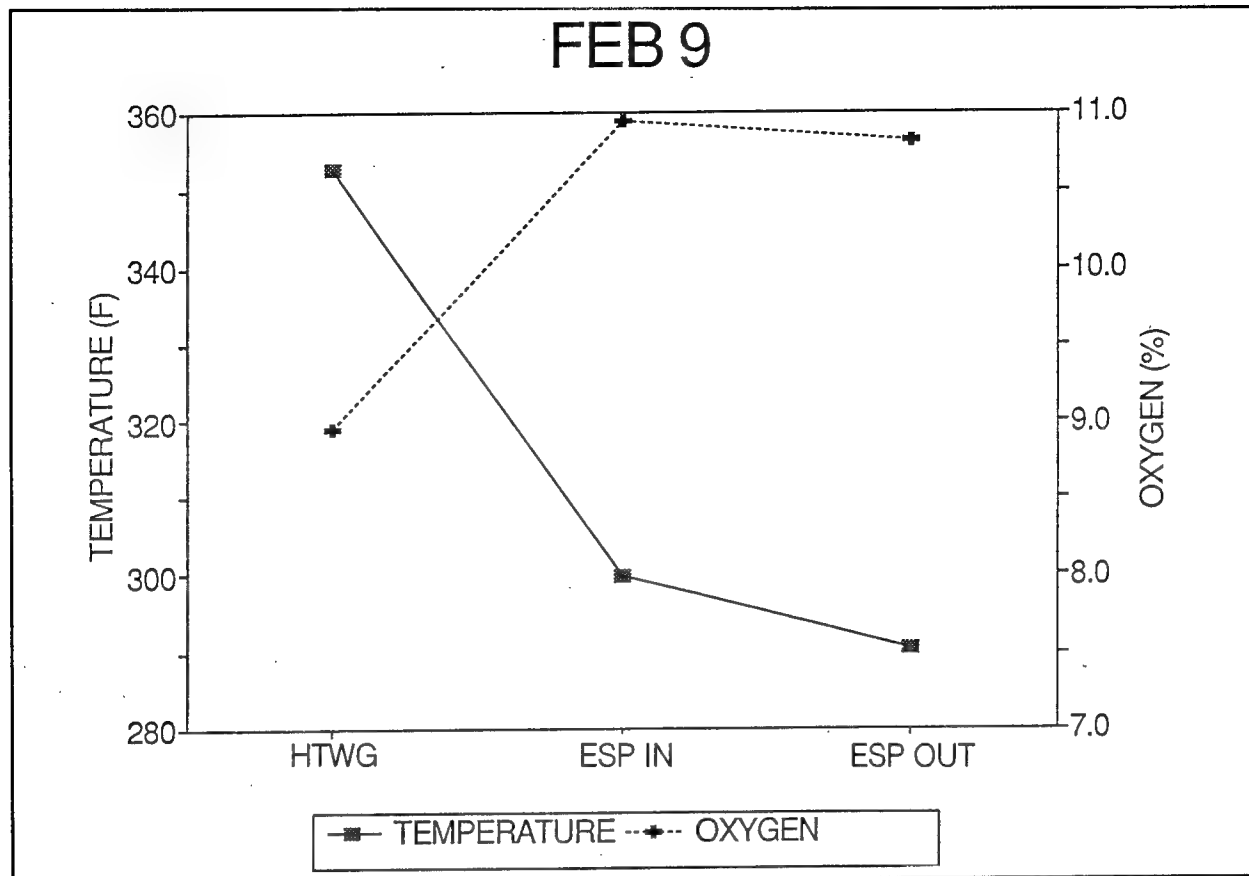
Figure 24. Pre-compliance test air infiltration.

An official compliance test was conducted about 1 month after the preliminary test. Generators no. 2 and 3 and ESP no. 1 were in operation. Table 11 summarizes the combustion and air infiltration data from the test runs. The average plant output was about 71 MBtu/hr with a combustion efficiency of about 85 percent. Figure 24 indicates the air infiltration through the ductwork and ESP. The graph again indicates a significant amount of infiltration between the HTWG and the ESP inlet, caused by leaking bypass dampers and stack caps. The temperature is adequate to protect against acid corrosion.
